Your Inspection Report

1821 California Avenue
Wahiawa, HI 96786

Wednesday, May 31, 2017

RE: Report No. 1016
1821 California Avenue
Wahiawa, HI
96786

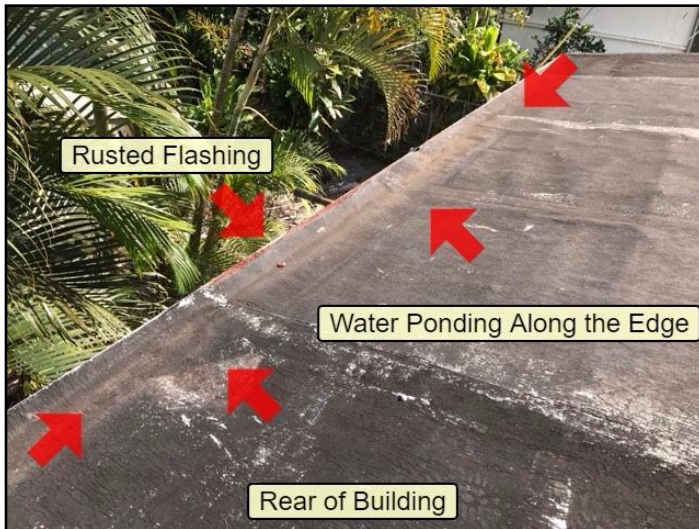
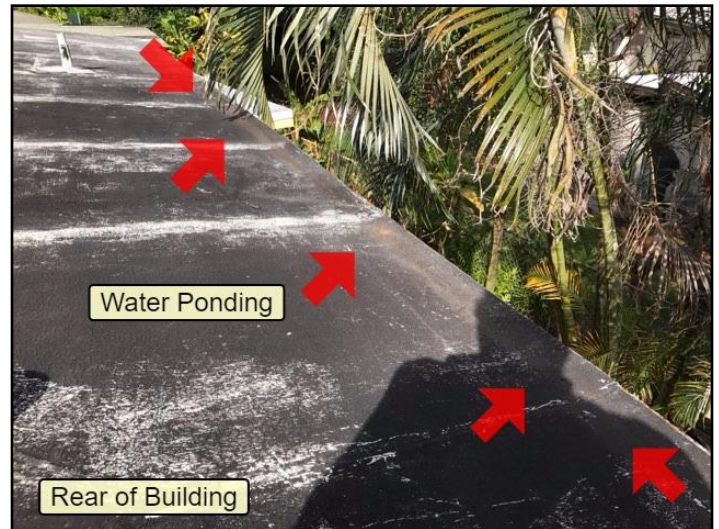
1. Condition: • [Rust](#)

Implication(s): Chance of water damage to contents, finishes and/or structure

Recommend consulting with professional roofer to evaluate condition and recommend the appropriate remedial action.

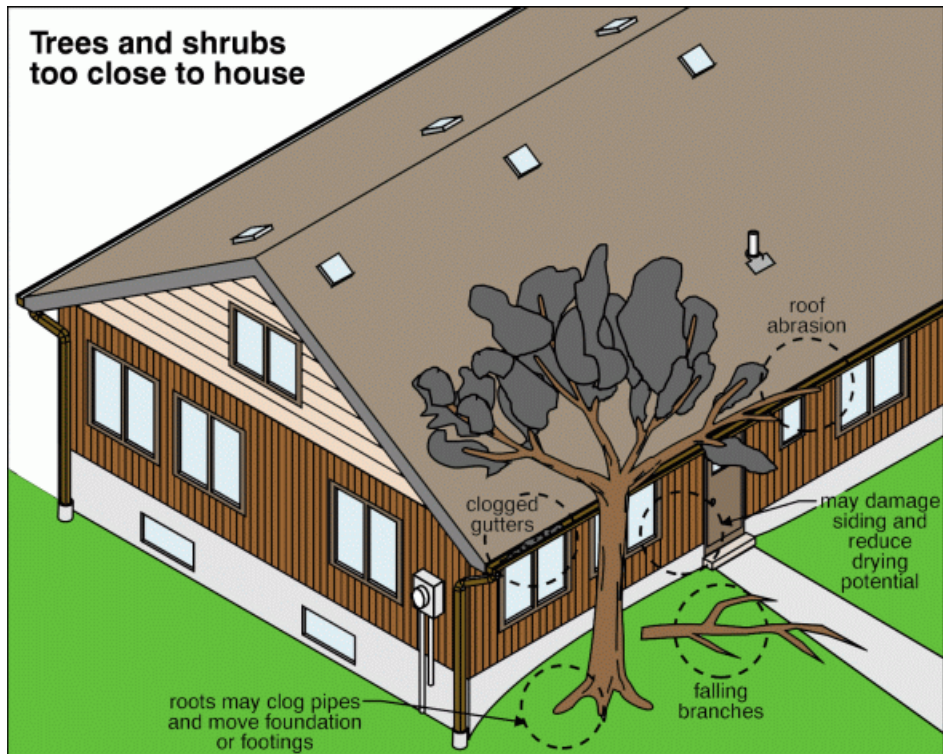
2. Condition: • [Trees or shrubs too close to building](#)

Implication(s): Chance of water damage to contents, finishes and/or structure | Chance of pests entering building | Material deterioration

Recommend consulting with an arborist to evaluate the condition and recommend the appropriate remedial action.

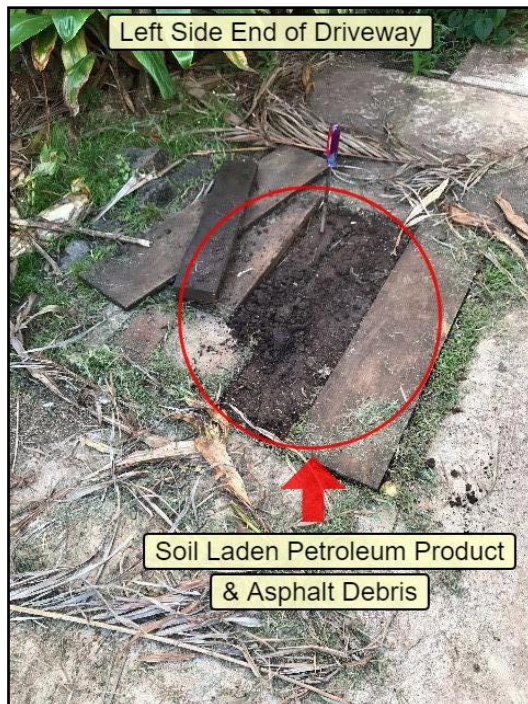
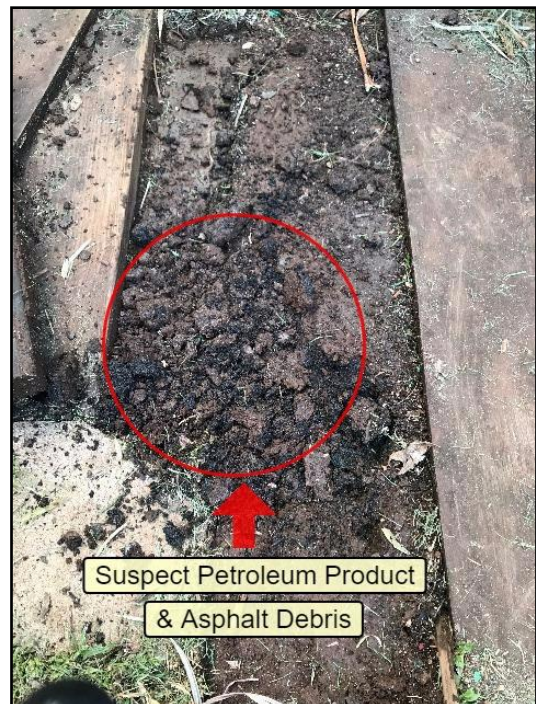
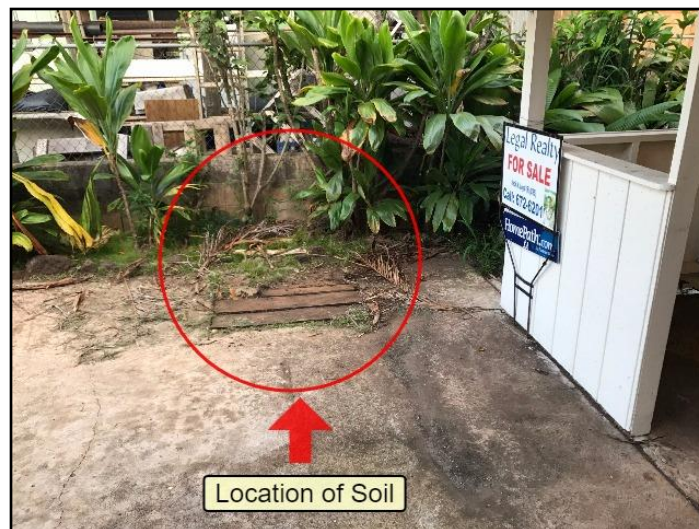
3. Condition: • During the inspection, investigated and uncovered what appeared to be an old cesspool cover on the left side of the property. The inspection revealed an area approximately 4 square feet wide of soil that appeared to be laden with petroleum product. The area had a strong odor of motor oil. A visual observation of the soil revealed blackened soil with a rainbow sheen and large chunks of broken asphalt material that seem to be at least 8 to 10 inches deep.

Recommend consulting with an environmental professional immediately to evaluate the condition and recommend the appropriate remedial action.

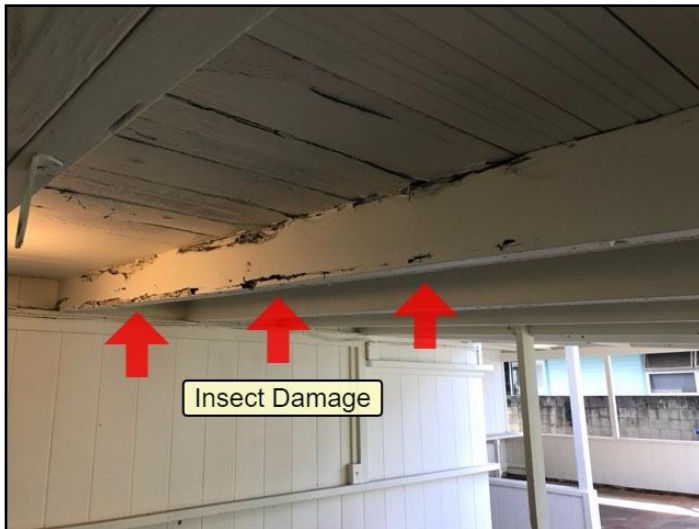
17. Insect damage

4. Condition: • [Insect damage](#)

Insect Damage. - Recommend consulting with a Entomologist to evaluate the condition and recommend the appropriate remedial action fort the condition.

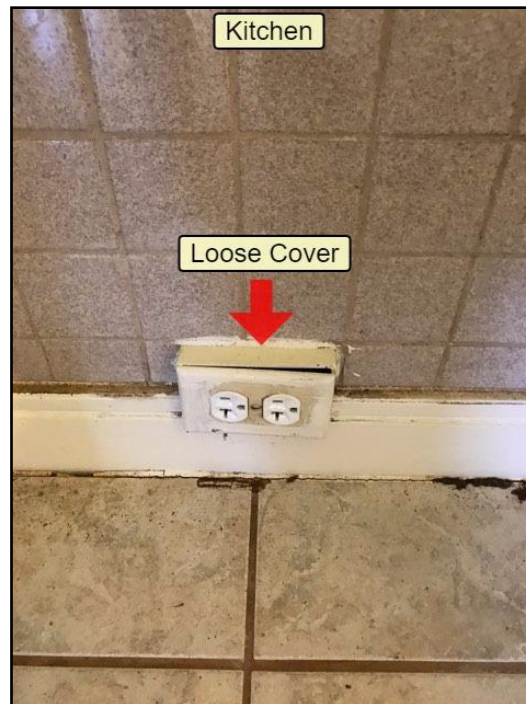
26. Loose Receptacle

6. Condition: • Cover separated from outlet.

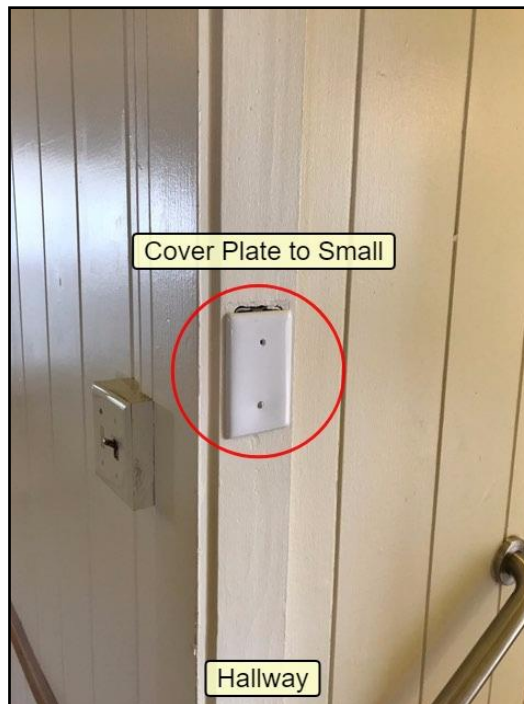
27. Cover Plate Too Small

7. Condition: • Cover plate to small. - Recommend replacing with the appropriate sized cover.

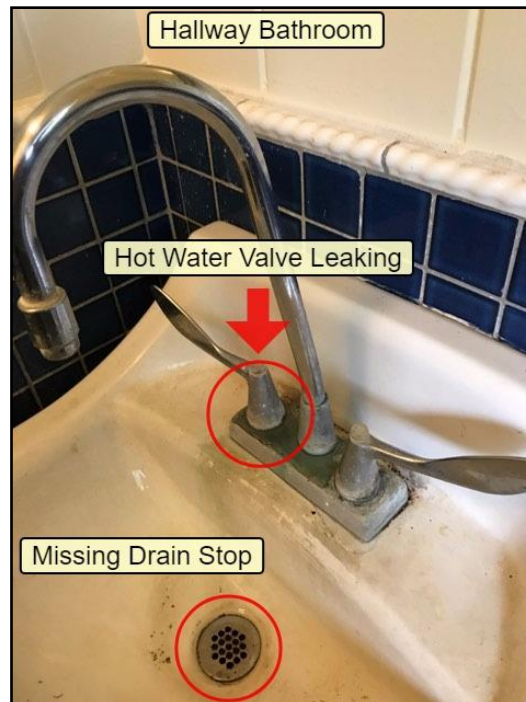
10. Condition: • Hot water valve on basin leaks. Difficult to shut off. Recommend consulting with professional plumber to evaluate and recommend the appropriate remedial action.

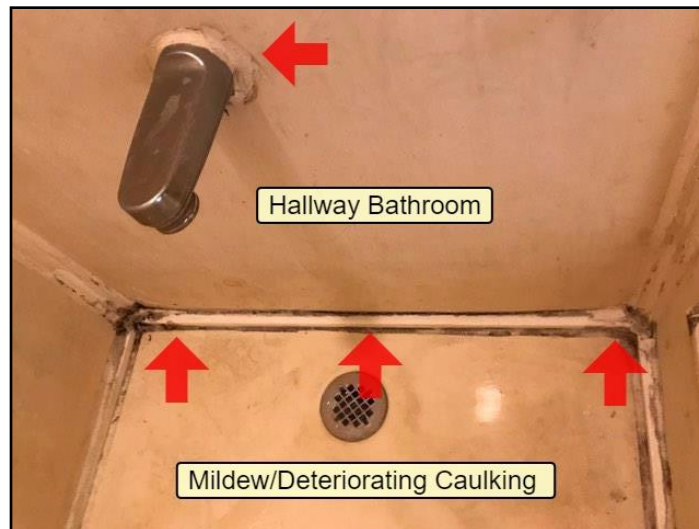
35. Shower Stall

12. Condition: • [Caulking loose, missing or deteriorated](#)

Caulking is covered in mildew and deteriorating along all joints. - Recommend maintenance to prevent further deterioration of caulking.

Implication(s): Chance of water damage to contents, finishes and/or structure

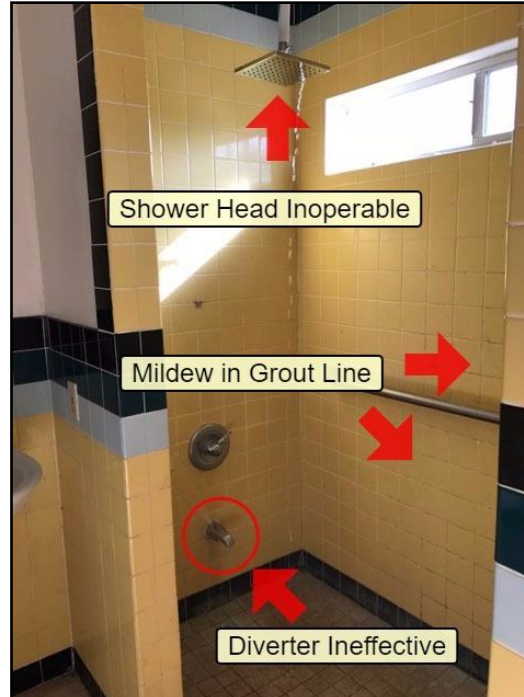
36. Master Bathroom

13. Condition: • [Grout loose, missing or deteriorated](#)

Grout is covered in mildew and is beginning to deteriorate along the transition joints. - Recommend maintenance in this area to prevent further deterioration of the grout.

Implication(s): Chance of water damage to contents, finishes and/or structure

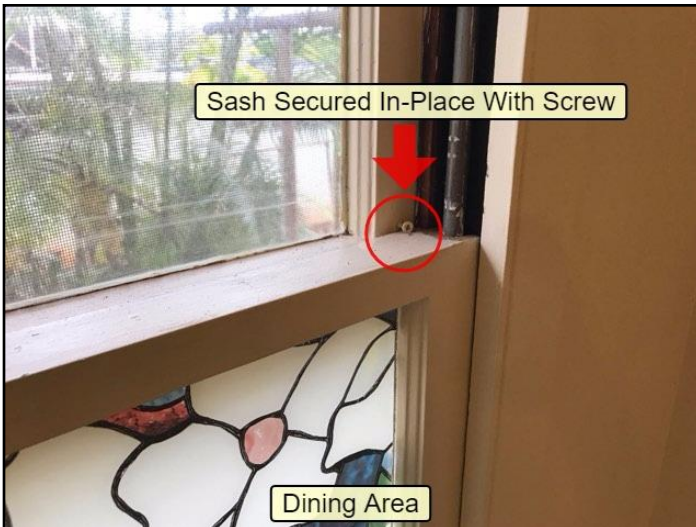
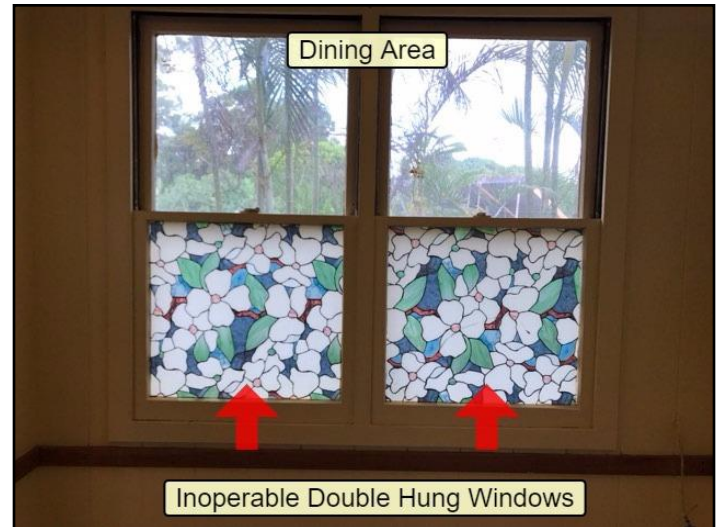
16. Condition: • Windows inoperable, window frames are permanently anchored with screws into the window sash and frame.

Implication(s): Fire Egress Hazard

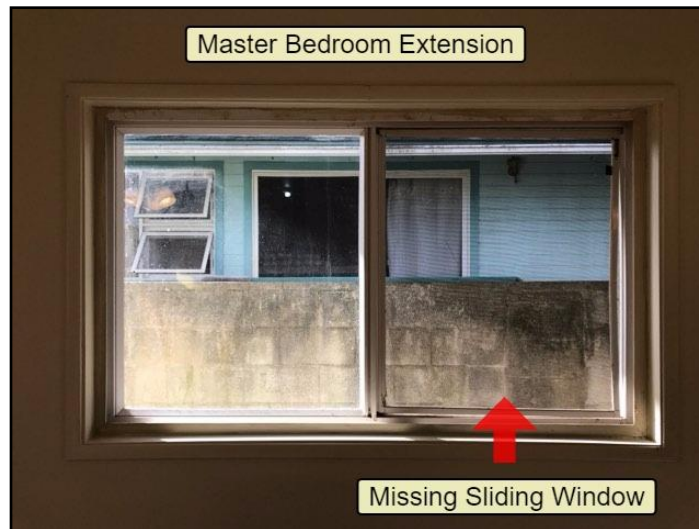
45. Slider Window

18. Condition: • Missing window, open and unable to secure and lock. Recommend repairing/replacing window.

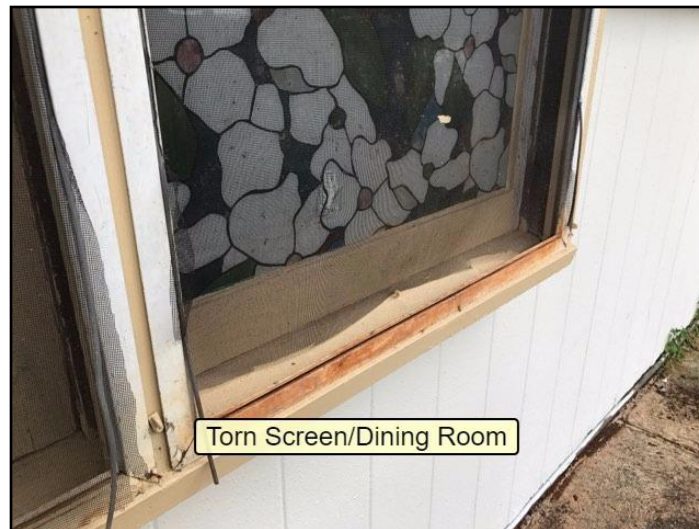
46. Torn

19. Condition: • [Torn](#)

Screen frame deteriorating, screen torn. Recommend repairing/replacing screen.
